Structural Repair of Galveston Island Historic Pleasure Pier Cycle of Life

Galveston Island Historic Pleasure Pier —
Structural Concrete Repair

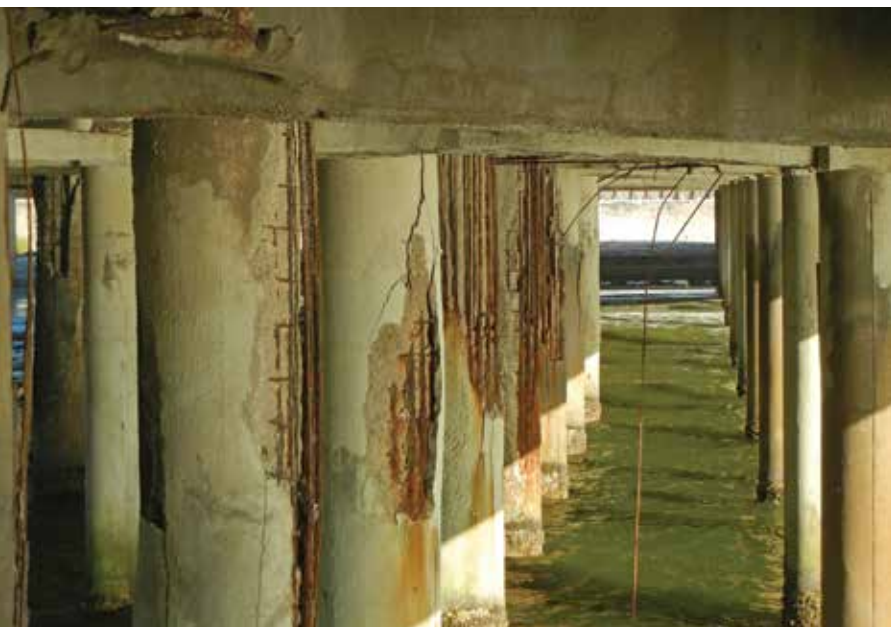
Little or no maintenance over the 70-year life of the pier has resulted in exposed reinforcing steel with accelerated corrosion and concrete spalling at piles, beams, joists, and reflective overhead flat plates. The new design plan increased live- and dead-load factors on the pier, harmonic motion of ride equipment, anticipated high lateral wind load

Fig. 1: Deteriorated columns between water line and deck

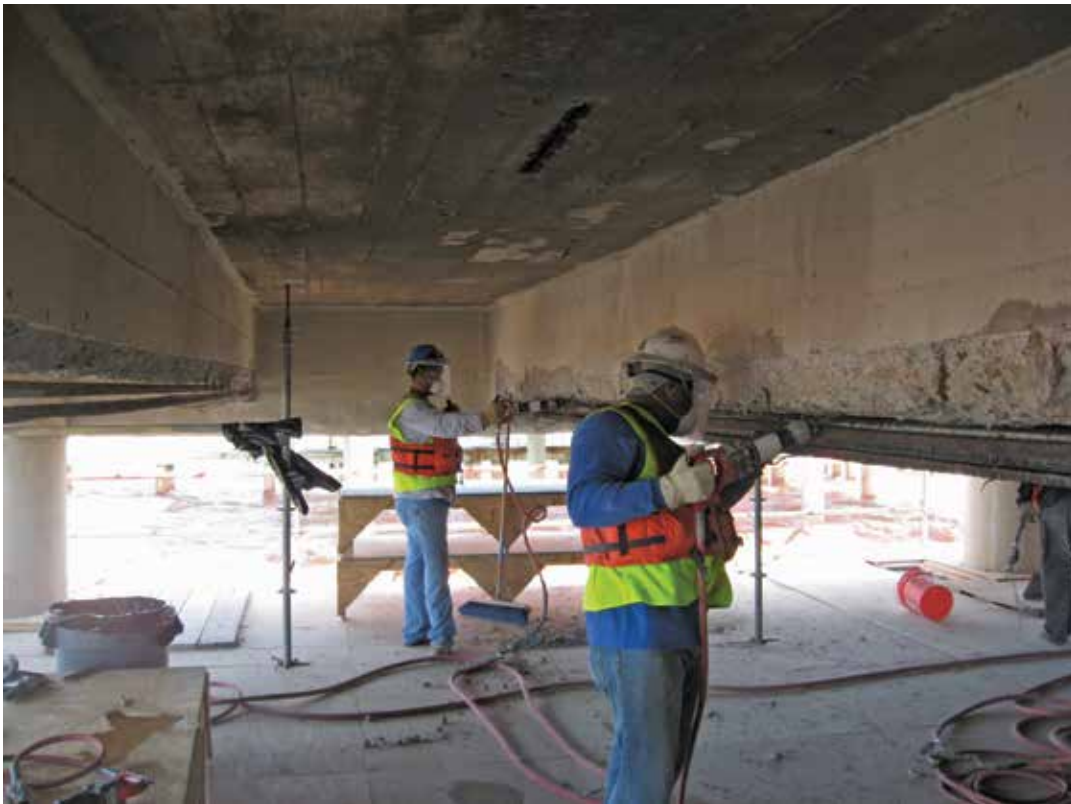
Fig. 2: Surface preparation of deck support beams

The on-site engineer inspected for sufficient removal of deteriorated/micro-fractured concrete; surface profile of mechanically prepared sound

concrete; minimum 1 in. (25 mm) concrete removal behind existing in-place reinforcing; complete corrosion removal at reinforcing; new steel placement; anchoring and lap splicing; anti-corrosion coating; and constant measuring of shotcrete thickness, cover at reinforcement, density, compression, and consolidation. Presoaking the properly prepared concrete substrate to surface saturated dry (SSD) ensured a monolithic integrated bond line between enhanced micro-silica shotcrete pneumatically applied freeform using three C-10 dry-mix shotcrete machines purchased from Gunitite Supply and Equipment in Houston, TX. Once each underside structural member received the required shotcrete thickness of material, the surface was struck and finished to match dimensions of the existing pier concrete. The on-site inspector monitored the shooting of test panels on a daily basis in accordance with material specifications accepted by the engineer and owner.

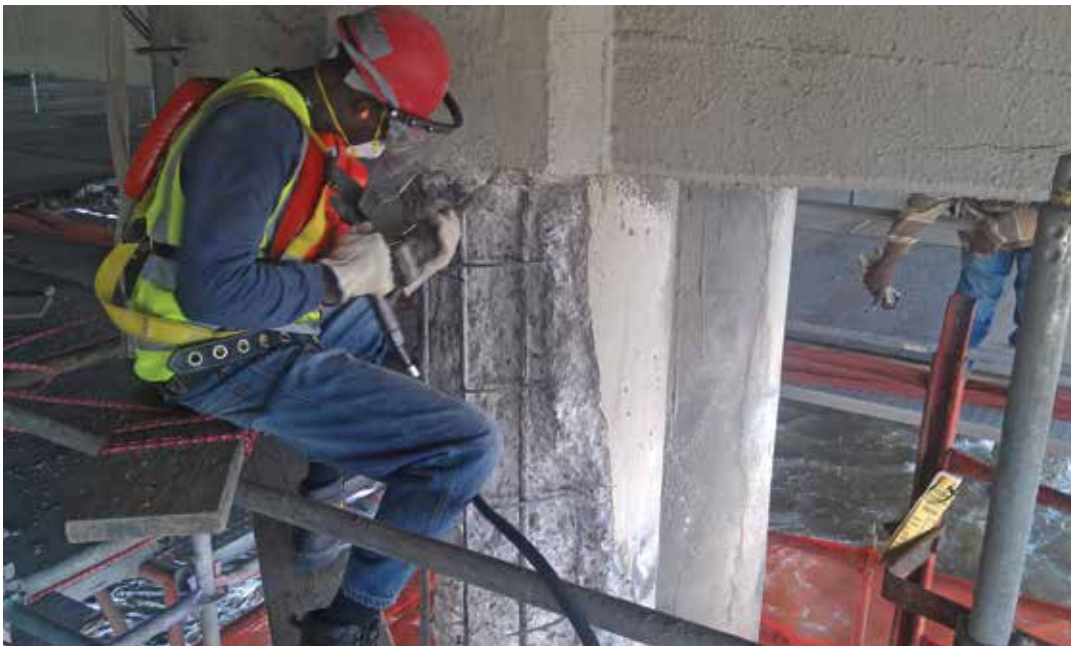
Fig. 3: Surface preparation of pier columns

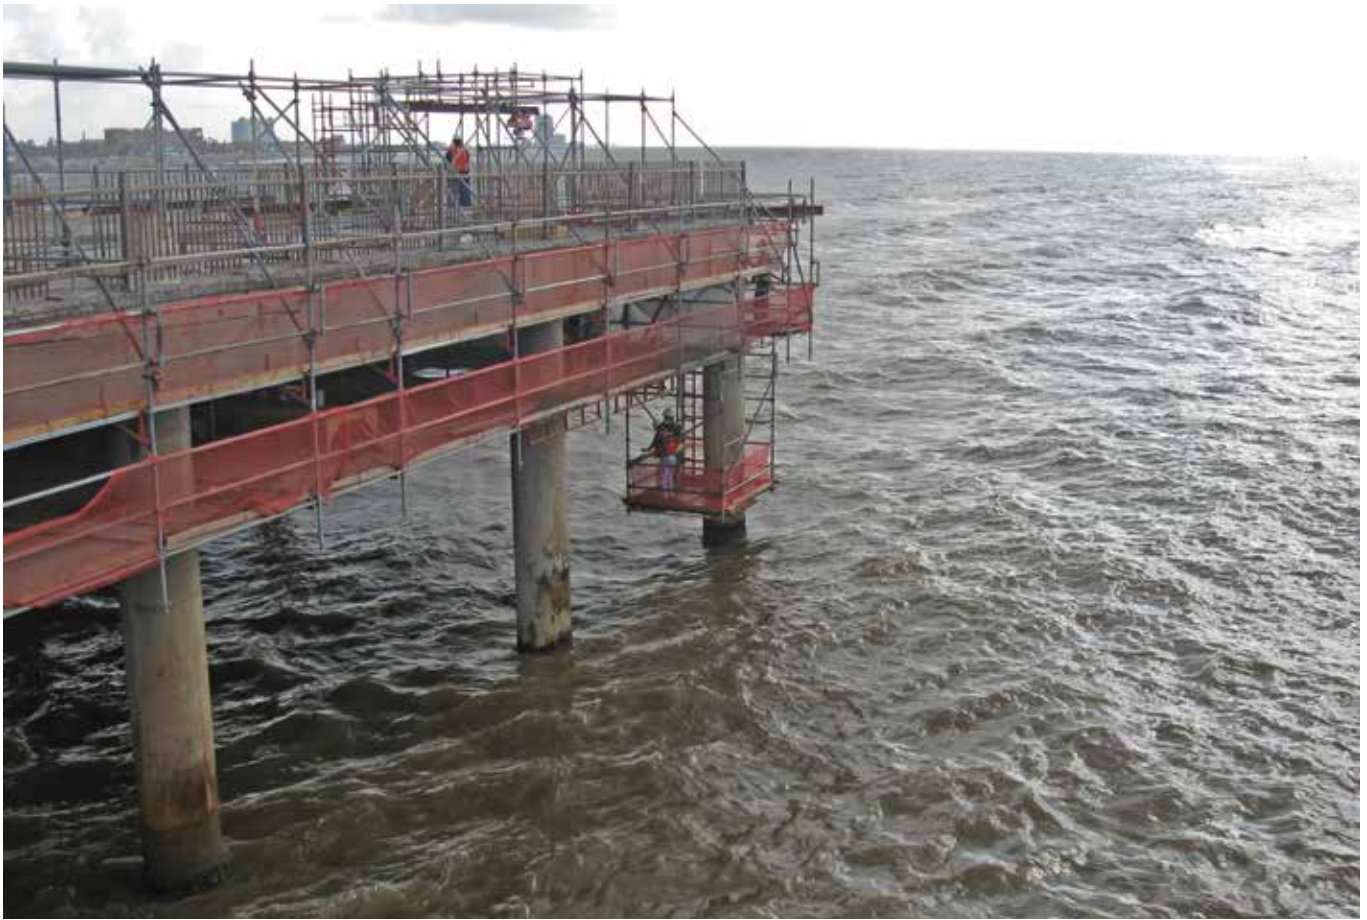
Fig. 4: Scaffolding setup for open access to underside of deck

corrosion material in advance of any shotcrete material. Access to the pier underside and safe support of all workers was a major problem for the duration of the project over salt water with wave action around pilings, tidal fluctuation, afternoon storms, and constant prevailing winds. Once the 10-story hotel was demolished one floor at a time by a specialty demolition contractor, working platforms 120 x 200 ft (37 x 61 m) were suspended and anchored 7 ft (2.1 m) below the pier deck and at existing concrete columns. Betco Scaffold of Houston designed, engineered, erected, and sequentially moved multiple sections to designated work zones, beginning at the farthest point over water allowing safe access for EDS to structurally restore each pier element (refer to Fig. 4). Environmental restrictions were in place throughout the project by the city of Galveston, the U.S. Coast Guard, and the Environmental Protection Agency (EPA) for concrete demolition dust control, debris removal, and cementitious overspray during shotcrete placement. Large tarps, screens, netting, tethers, and tie-offs were present each day as workers restored each platform section in a predetermined repair sequence to completion (refer to Fig 5).

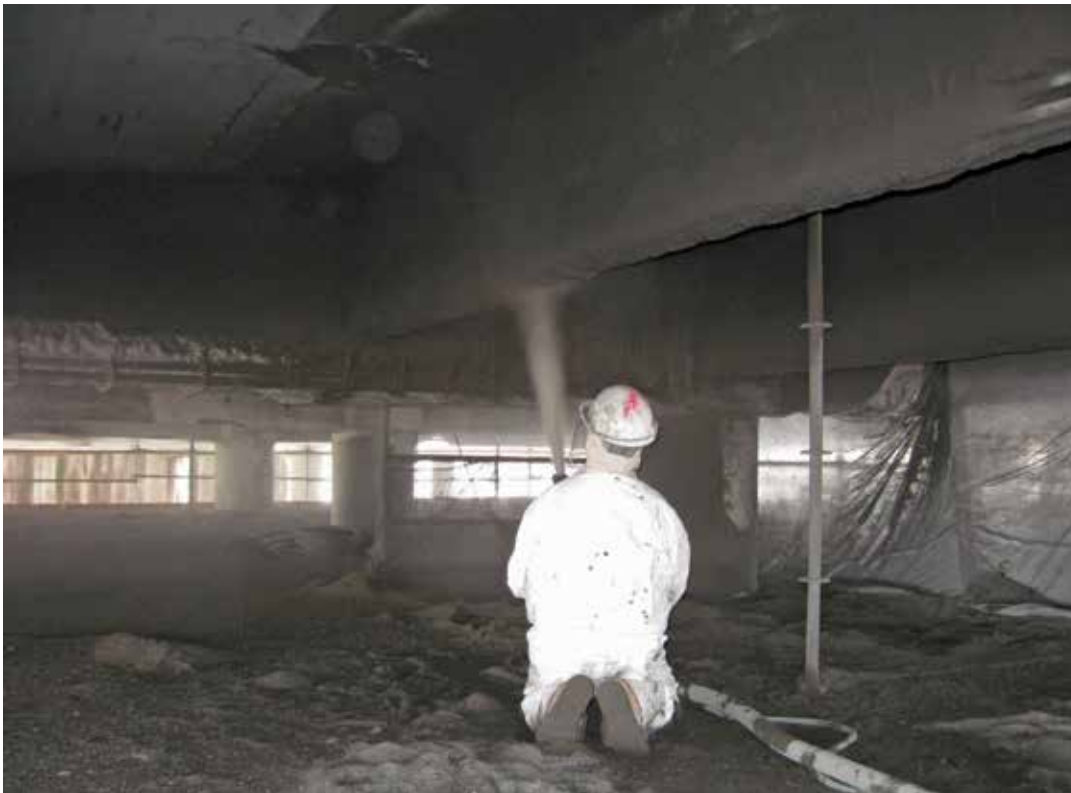
Fig. 5: Shotcreting deck beam overhead with very limited access height
